APOLLO 11 MISSION

ANOMALY REPORT NO. 2

GLYCOL TEMPERATURE CONTROL VALVE

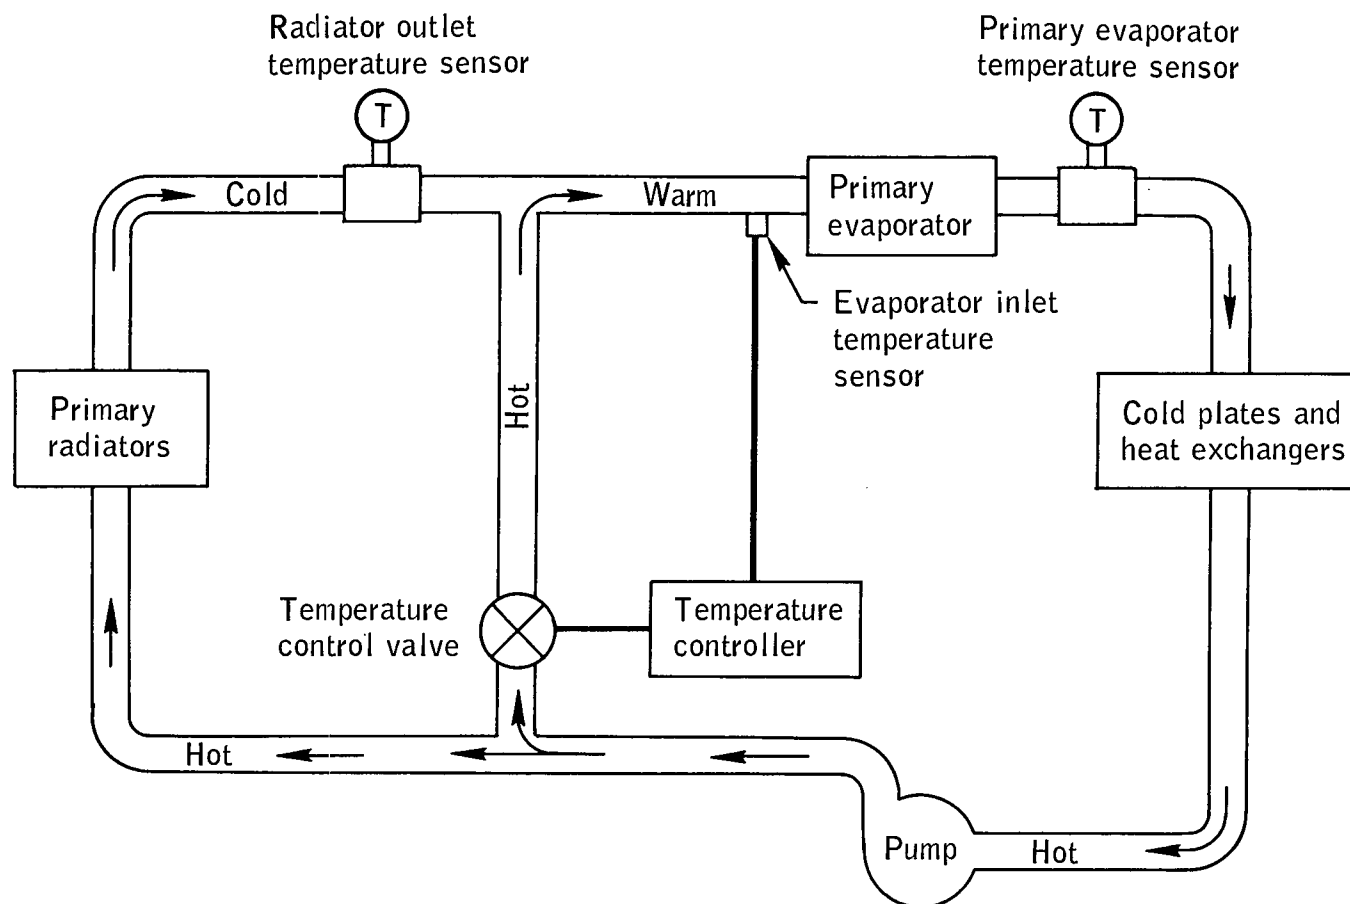
Figure 1.- Primary water/glycol coolant loop.

Normally for low radiator outlet temperatures, the glycol temperature control valve automatically maintains the evaporator inlet temperature between 42° and 48° F (fig. 1). As the radiator outlet temperature falls below 48° F, the glycol temperature control valve modulates open and allows hot water/glycol to mix with the colder water/glycol, thus maintaining the required evaporator inlet temperature. Conversely, as the mixed water/glycol temperature increases above 42° F, the valve starts to close and is completely closed when the evaporator inlet temperature rises above 48° F. When the mixed water/glycol is 42° F or less, the valve is fully open. The valve can also be operated manually by removing power from the control circuit.

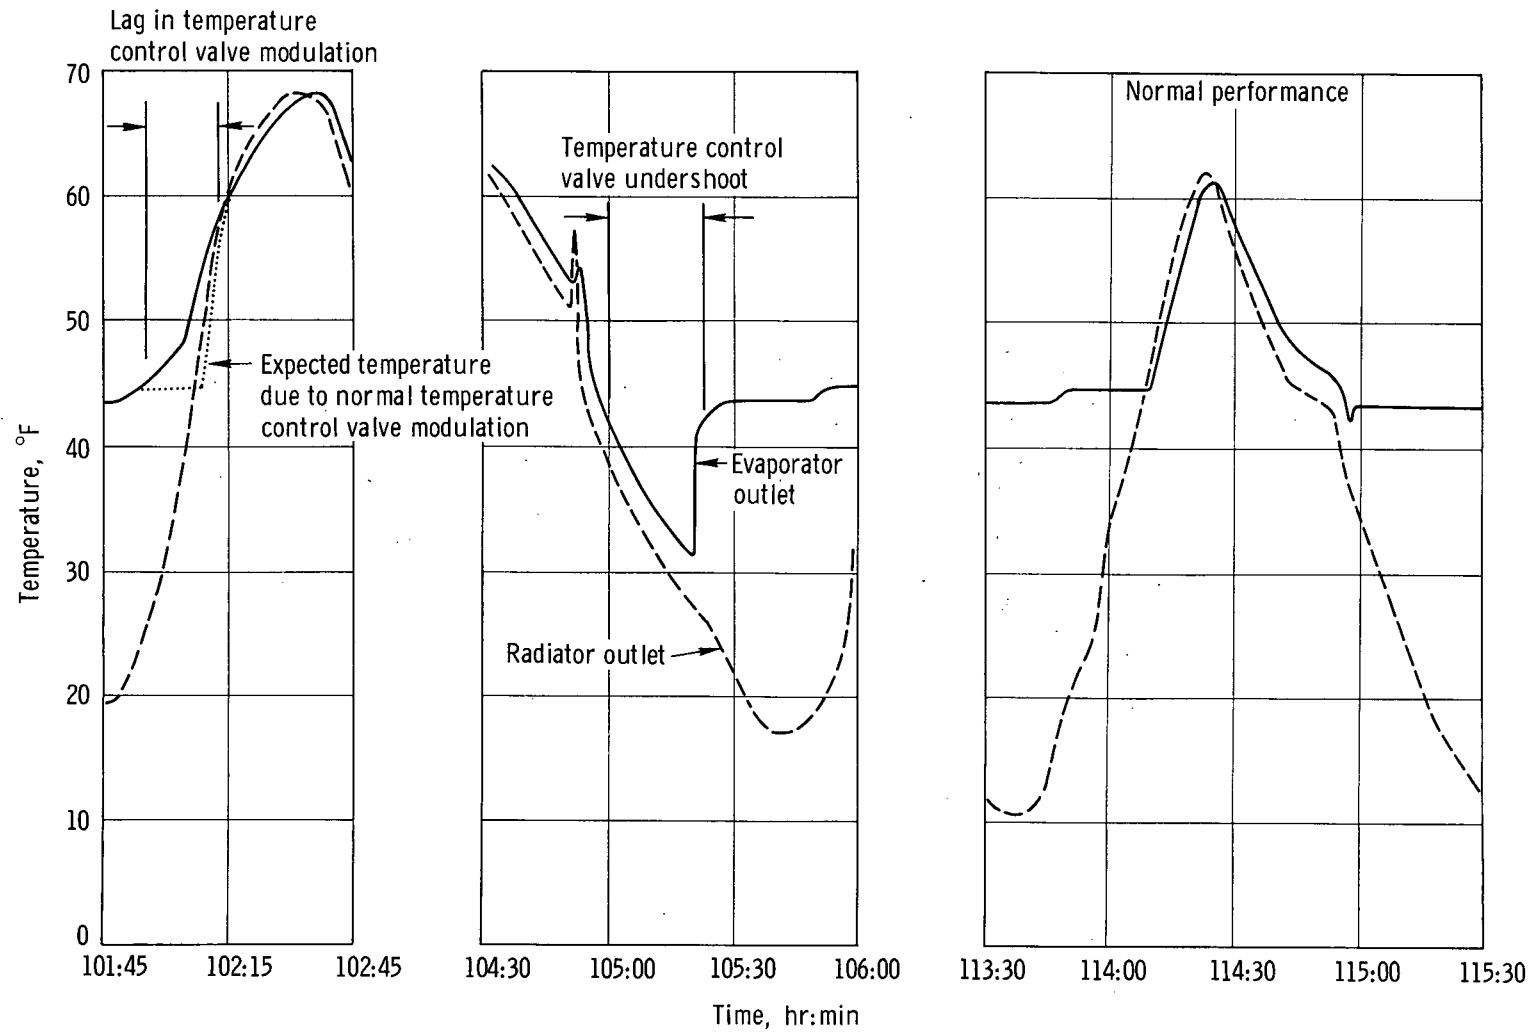
Figure 2. - Comparison of radiator and evaporator outlet temperatures.

Two effects of the anomalous valve operations were experienced during the mission. The first was noted during a portion of earth orbital flight as well as during most of the first 15 revolutions of the moon. As the temperature of the cold water/glycol returning from the radiators started increasing the temperature control valve failed to control, thus causing a premature increase in the evaporator inlet temperature. The most severe case occurred during revolution 14 when the valve did not close until the evaporator inlet temperature reached approximately 58° F (fig. 2).

The second effect of the anomalous operation occurred during revolutions 5, 13, and 15 (fig. 2) when the mixed water/glycol temperature decreased below 42° F. During revolutions 5 and 13, temperatures of 36° and 38° F, respectively, were noted before valve operation returned the temperature to the nominal control range. During revolution 15, an undershoot was observed (fig. 2). About this time, the temperature inlet switch was cycled from AUTO to MANUAL and back to AUTO and the evaporator outlet temperature began increasing from a low of 32° F until a temperature of 45° F was reached. During all subsequent mission phases, the glycol temperature control valve operated satisfactorily.

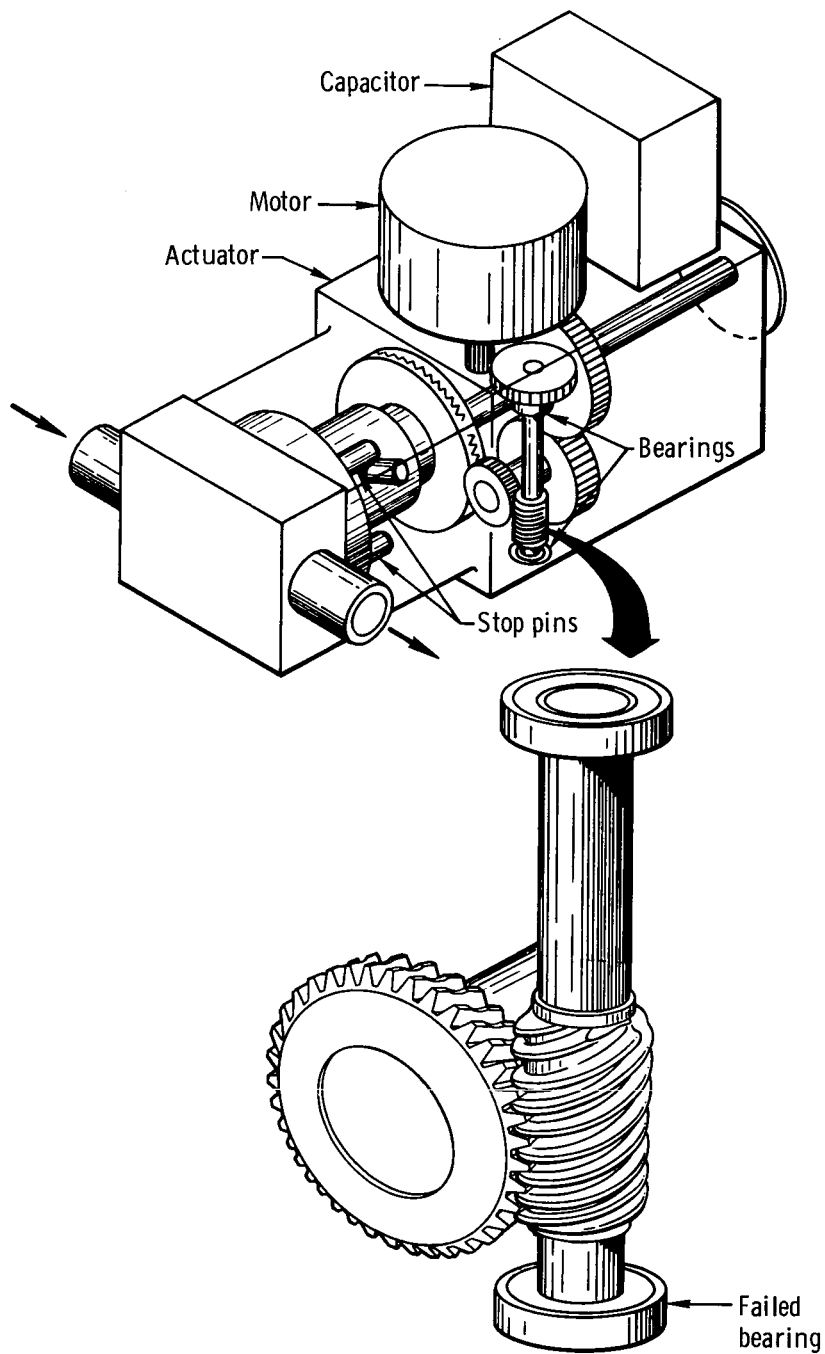
Figure 3. - Bearing assembly within temperature control valve.

Postflight testing demonstrated that the glycol temperature controller, which powers the temperature control valve, functioned properly and supplied correctly modulated pulses to the valve for a full range of input temperature signals. Corresponding valve response, however, appeared sluggish. Disassembly of the valve revealed that a bearing on the worm gear shaft in the actuator (fig. 3) had failed.

(a) Location of failed bearing.

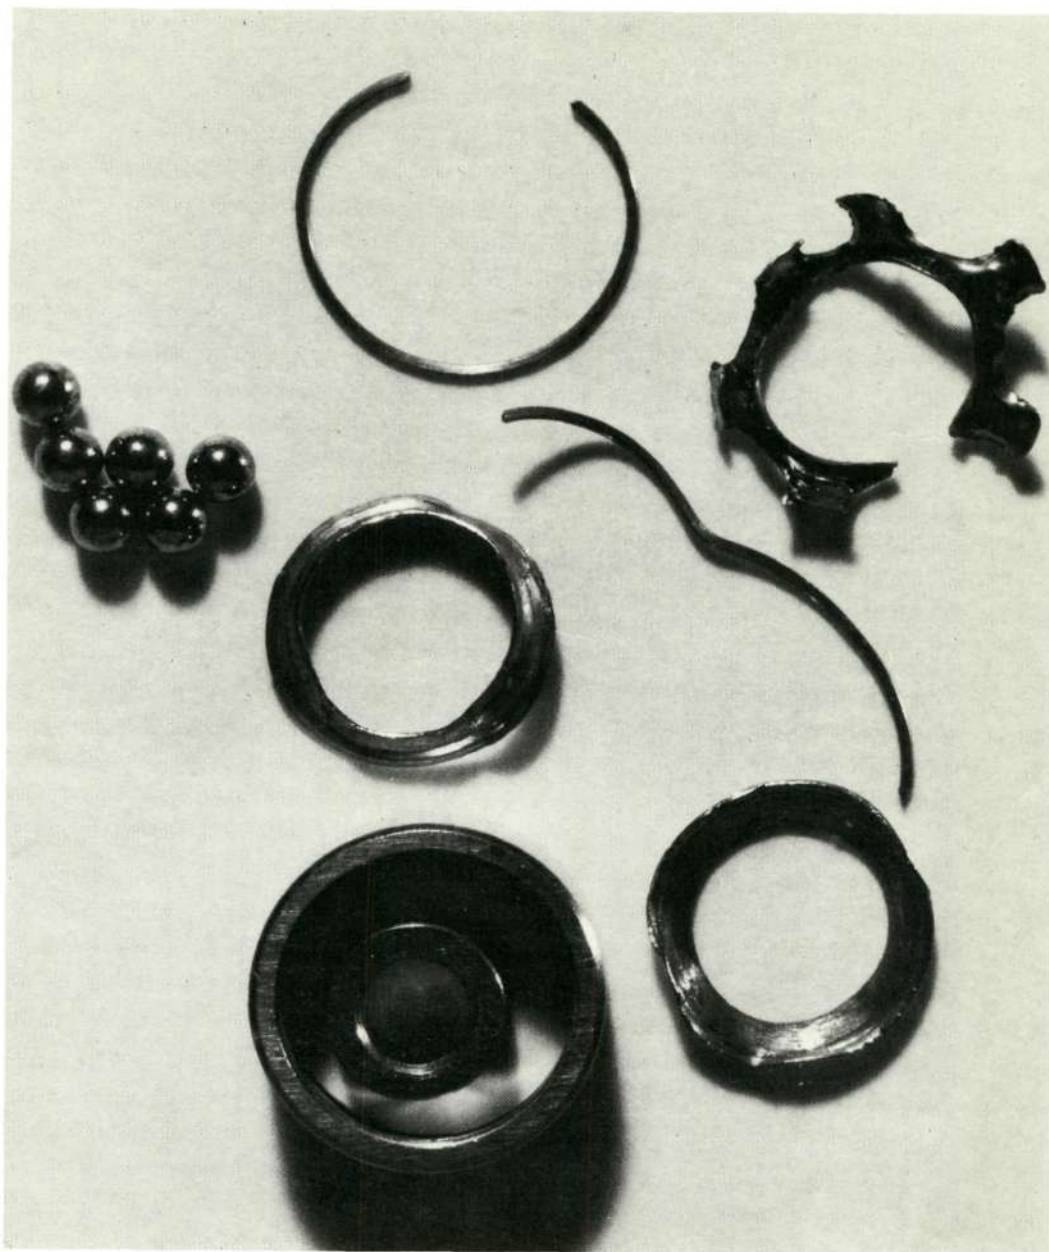
Figure 3.- Concluded.

The valve has no electrical stops so that when it is commanded full open or closed, the motor drives the gear train into hard mechanical stops and stalls. Analysis showed that when the gear train is driven into the stops, the bearing is subjected to a total thrust load of 90 pounds. The bearing is rated for 20 pounds static thrust by the bearing manufacturer.

Examination of the bearing pieces showed that the sudden application of static thrust load at stall combined with poor boundary lubrication characteristics of the bearing lubricant resulted in fretting corrosion of the bearing race. The wear debris then accelerated the wear and eventually jammed one ball in the race, allowing the ball behind it to bend the ball retainer ear (fig. 3). When several of the ball retainer ears were bent out, the balls accumulated on one side and broke the ball retainer. Ball pressure then forced the shield out and the bearing disassembled itself.

The design allowed an application of loads which are beyond the rated capability of the bearing.

(b) Failed bearing assembly.

If the temperature control valve should fail in flight, an existing malfunction procedure will be used to manually position the valve to

approximately 35-percent bypass. This position will maintain a predetermined relationship between radiator outlet and evaporator outlet temperatures that only slightly increases overall system temperatures during periods of high heat loads.

Valve failure will not compromise future missions because by using an existing procedure the valve can be manually set at one position which will meet system requirements; consequently, no corrective action is required.
